Paper number	1156
Paper title	The use of partial discharge monitoring and failure analysis of a 275 kV oil filled current transformer
Study Committee	SC A3 –Transmission and distribution equipment
Paper Stream	1. Learning from experience
Authors	Brody WARD, Tim MACKLIN
Affiliations (optional)	Powerlink Queensland
Email address	brody.ward@powerlink.com.au

Case study – Failure of 300kV current transformer

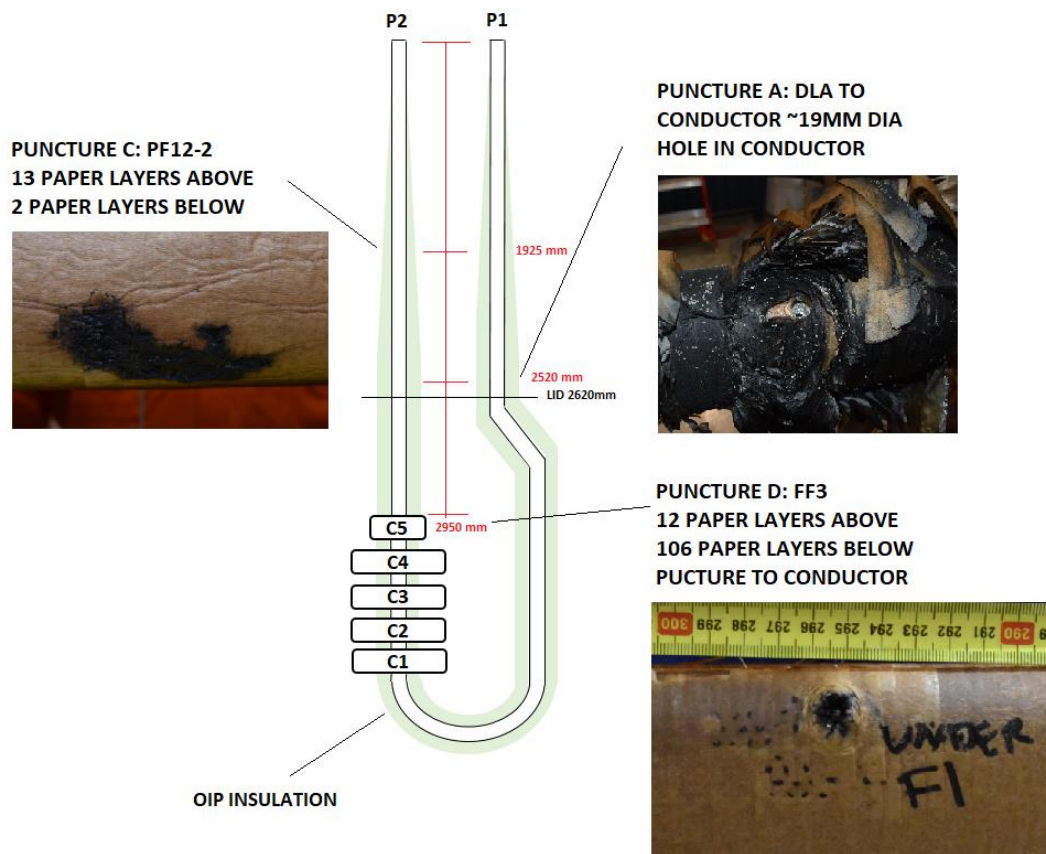
The forensic investigation of the B phase unit provided the organisation with a thorough understanding of the failure mechanism, including the pressure relief and location of the insulation breakdown. The current transformer was a “Hairpin” style design manufactured in the 2000’s. Constructed of graded paper and foil insulation system including partial foil layers. Investigations illustrated three points of dielectric breakdown as shown below.

Figure 1 - Locations of insulation breakdown in failed current transformer. Puncture B (not pictured) refers to a mark on the tank correlating to arcing fault from Puncture A.

The investigation by both the manufacture and Powerlink concluded the current transformer was subjected to a lightning impulse sometime in the 3 years prior to the failure. Failure was then initiated during a routine switching sequence resulting in a cascade of prior weakened insulation.

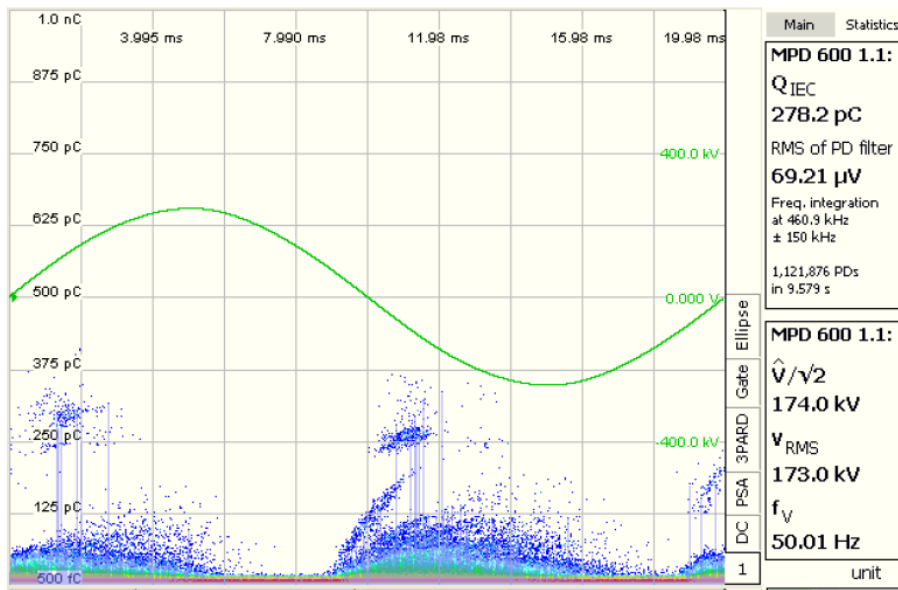
Prior to repeating type and routine tests, partial discharge measurements were taken to establish a benchmark. While Oil samples DGA and Dielectric Loss angle testing returned satisfactory results, off line partial discharge testing detected void type partial discharge arcing, results of which are recorded below:

Figure 3 - Phase resolved partial discharge measurements prior to impulse tests

These results indicate void type partial discharge, it is possible with continued operation in this condition an additional explosive failure may have occurred. Additional testing in both a field and laboratory environment proved beneficial from a safety and reliability stand point.

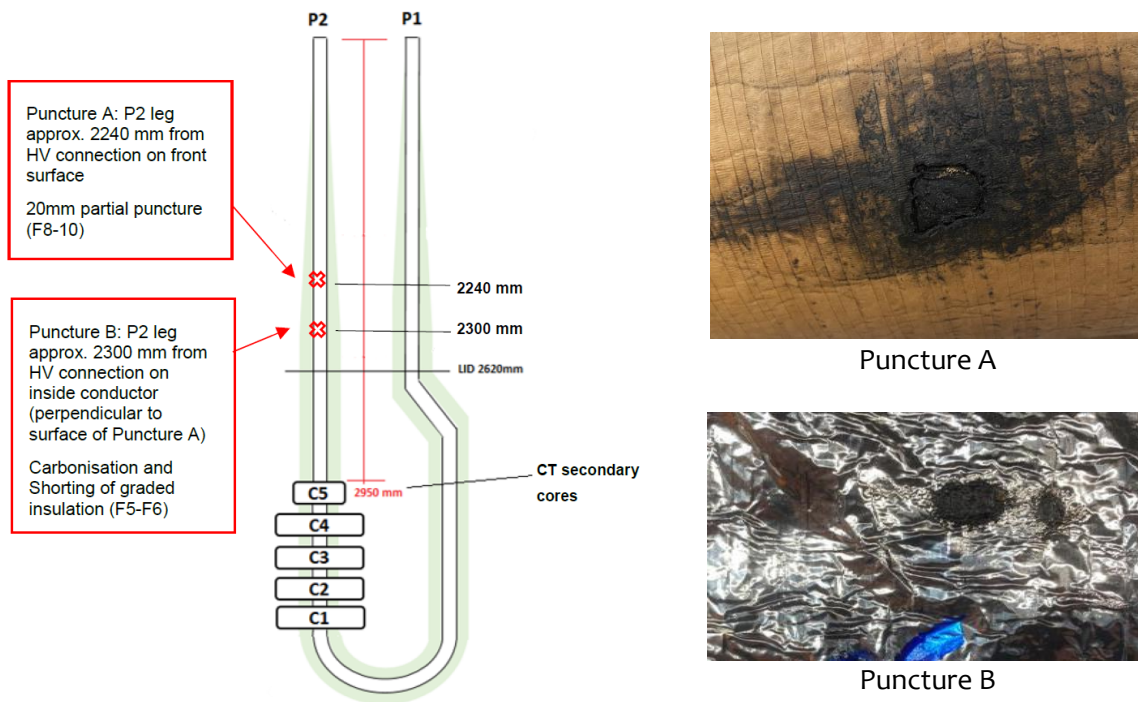
After completion of testing, the unit was returned to Powerlink and forensically investigated to confirm presence of discharge activity. Findings from this investigation found several location where the insulation system was compromised, similar to that of the B phase unit.

Figure 6 - Location of PD activity in C phase current transformer

As a risk mitigation measure following the incident, additional partial discharge surveillance was implemented at the site where the incident occurred. Several solutions were employed and explored to provide maximum monitoring and alert. The first line of defence was the use of unfiltered AM radios as a way early alert system to field based staff.

Due to planned secondary systems replacement works in an adjacent section of the yard, a solution which did not require additional outages for plant was preferred. The chosen method of monitoring consisted of a monitoring unit with online TEV system with automated alerting. This provided asset owners with the ability to use real time data to make dynamic operational decisions and give the most forewarning to field based staff on the development of partial discharges. The system monitored continually for a period of 12 months following the failure, with no indication of further evolving faults. Additionally, the site was scanned manually using UHF technology on a routine bases to monitor for fault evolution.
